Degradation modes and tool wear mechanisms in finish and rough machining of Ti17 Titanium alloy under high-pressure water jet assistance

Y. Ayed ^{a,*}, G. Germain ^a, A. Ammar ^a, B. Furet ^b

A B S T R A C T

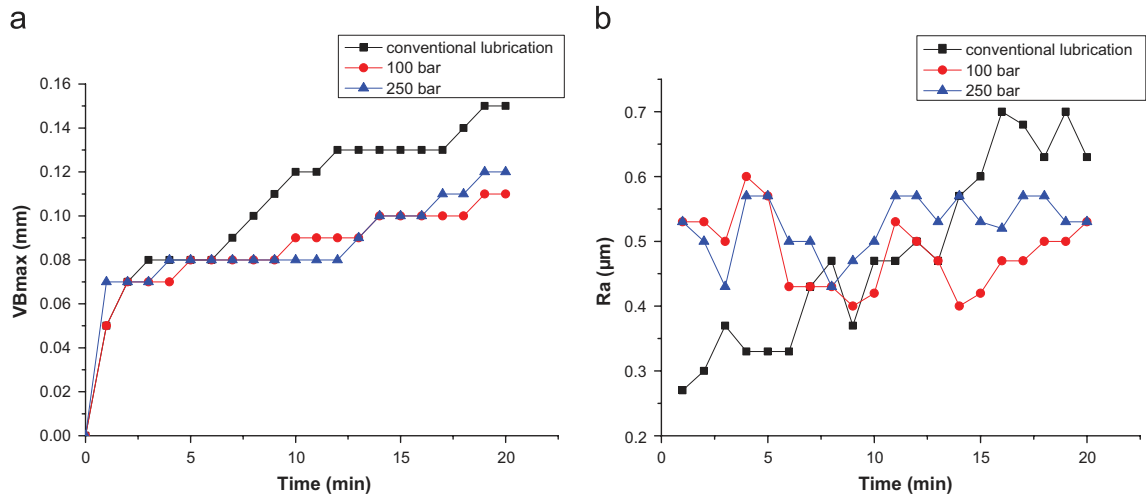
Fig. 3. (a) Flank wear (VB) and (b) surface roughness (R_a).

Fig. 3(a) shows the evolution of the flank wear criterion (VB) and (b) the evolution of the R_a criterion. For all the configurations, flank wear (VB) does not exceed 0.15 mm after 20 min of machining, but its evolution is slower with HPWJA. Indeed, in conventional lubrication after the running-in phase, flank wear increases linearly to 0.15 mm after 20 min.

However, for the HPWJA condition, after the running-in phase, the flank wear remains constant for a significant period. Indeed, in both assistance configurations (100 bars and 250 bars), flank wear remains constant at about 0.08 mm for approximately 6 min at a pressure of 100 bars and for about 9 min at a pressure of 250 bars. After this stable regime, flank wear increases in a way similar to conventional lubrication. Fig. 3(b) shows a significant variation of surface roughness. For conventional lubrication, the surface roughness tends to increase linearly as a function of machining time, going from $R_a = 0.25 \mu\text{m}$ to $R_a = 0.7 \mu\text{m}$ (i.e. R_a reaches three times its initial value). For tests with high-pressure water jet assistance, the initial surface roughness is higher, but its value remains globally constant (between $0.4 \mu\text{m}$ and $0.6 \mu\text{m}$ throughout the test). In addition, there is no marked tendency for the surface roughness to increase even at the end of the test. The surface roughness thus appears uninfluenced by flank wear.

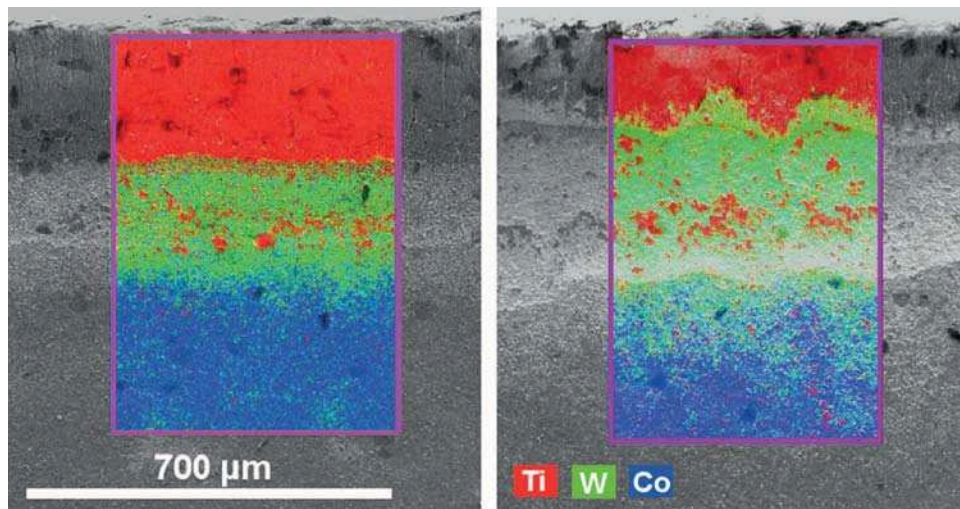
Fig. 15. EDS analysis after 4 min of roughing machining (100 bars and 250 bars, respectively).

Fig. 15 shows the tool rake face of two inserts after 4 min of roughing machining at 100 bars and 250 bars, respectively. It can be seen that the area of the adherent layers becomes smaller when the pressure is increased from 100 bars to 250 bars. In fact, the order of magnitude of the contact length is close to that found in the finishing condition.

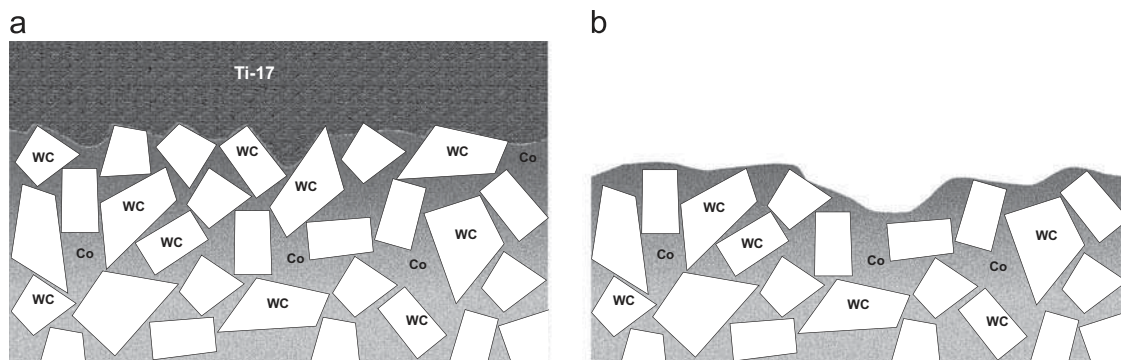
Fig. 16. Mechanism of adhesive wear.

Fig. 16 illustrates wear by adhesion. In fact, during the tool/chip contact, an interfacial layer of titanium is formed. Combined with the high temperature and high contact pressure, this layer reacts chemically with the tungsten carbide and adheres to the surface of the insert [8,11]. Thus, an increase in the cutting temperature promotes the diffusion between the tool and the chip. This deposited layer seems to protect the tool since the chip is no longer directly in contact with the carbide tungsten. However, after a period of time, the deposit may become unstable and so can be torn off by the chip. In this case, it tears fragments of the tool material leading to wear by adhesion. These findings confirm the results of other studies on adhesive wear of nickel-based alloys. Devillez et al. [19] and Bhatt et al. [11] show via SEM pictures and EDS analysis the formation of a sticky layer; it is to be noted that when this layer is pulled-out, it causes the adhesive wear.
